Manhole Inspection Summary

Manhole # S27I__046MH

Insp Date: **5/27/08 9:41 AM**

Location Address: **910 W Pratt St**

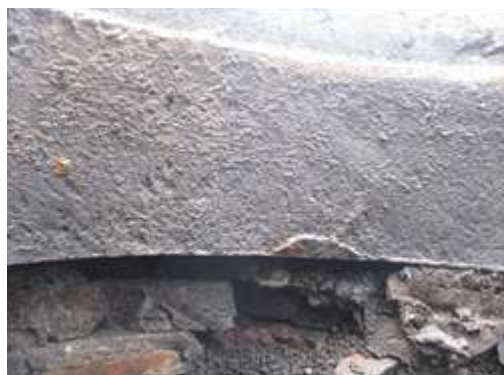
Defect 2

chimney joint, chimney cond loose bricks,
chimney deteriorated, mortar

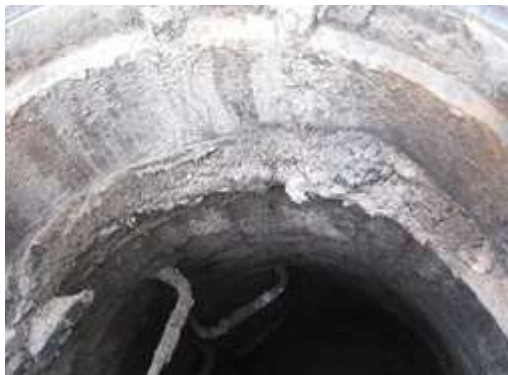
Defect 1

Frame Offset: **2.5** (in.) Condition: ☐ Sound ☐ Cracked ☒ **Leaks**

chimney flow wall, frame offset

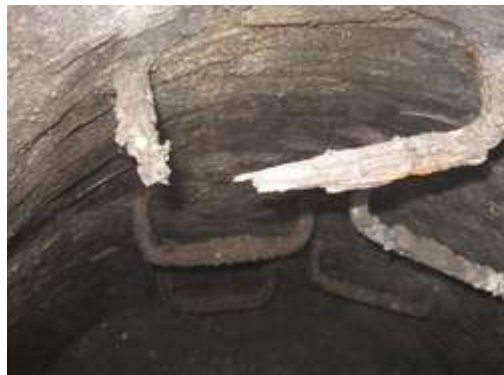
Defect 3

broken corroded rung; corbel and barrel deteriorated; bench debris

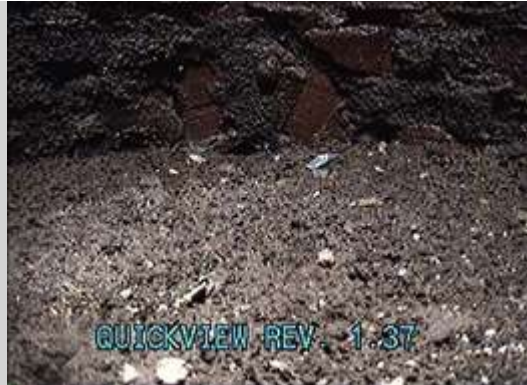
12 O'Clock Outflow

Comments **unable to obtain correct invert measurement due to heay soil sediment in MH, 12 oclock pipe is coverd by debris**

8 in. Circular Gravity Sewer
Pipe Out @ 12 O'Clock

Deposits: ☐ None ☐ Mud ☐ Sludge ☒ **Debris** ☐ Grease

Silt Depth: **8** (in.) Deposits Extent: **Heavy**

Infiltration: **Evidence** Pipe Seal Cond: **Unknown**
